Sedimentation Study Report

September 2022
Grand Lake Sedimentation Study

Updated Study Report

Prepared for
Grand River Dam Authority
P.O. Box 409
Vinita, Oklahoma 74301

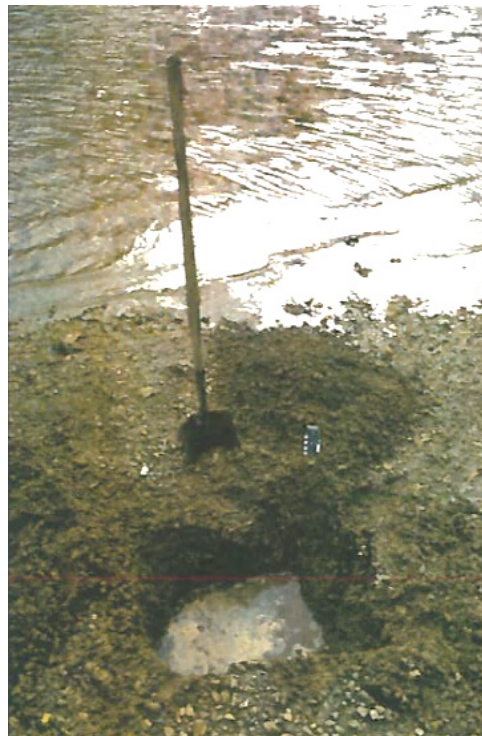
Figure 24

Typical Sand and Gravel Material on a Point Bar Along the Left (North) Side of the Neosho River at Approximately RM 147

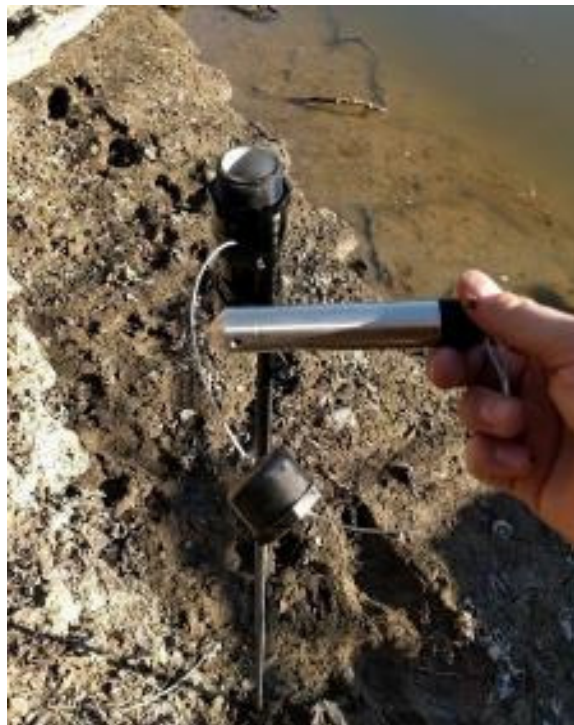
Figure 26
Photograph of HOBO Pressure Loggers and Mounting Chamber

Loggers were placed in a mounting chamber and attached to rebar driven into the bed at each location shown in Figure 23. The mounting chamber was constructed of PVC with threaded caps painted black to limit visibility and deter theft or vandalism. Rebar was driven into the bed to a sufficient depth to prevent the loggers from washing away during high flow events.

Anchor QEA collected WSE data throughout the Project site (Figure 23). Sixteen monitoring locations were selected, and HOBO pressure loggers (Figure 26) were installed at each site in December 2016. The loggers record raw pressures and water temperatures at 30-minute intervals to provide a continuous WSE record throughout the basin. Data are stored in onboard memory; with 30-minute recording intervals, the memory capacity is approximately 1.2 years.

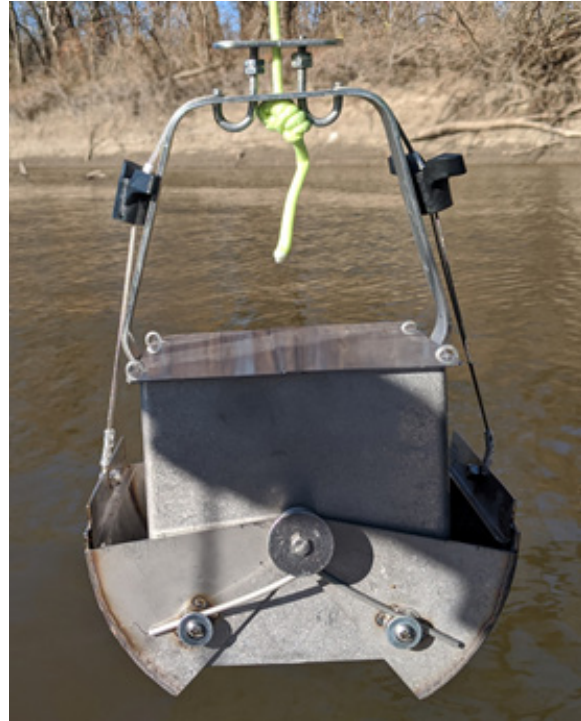
Figure 28
Ekman Dredge Used for In-Channel Sediment Sampling

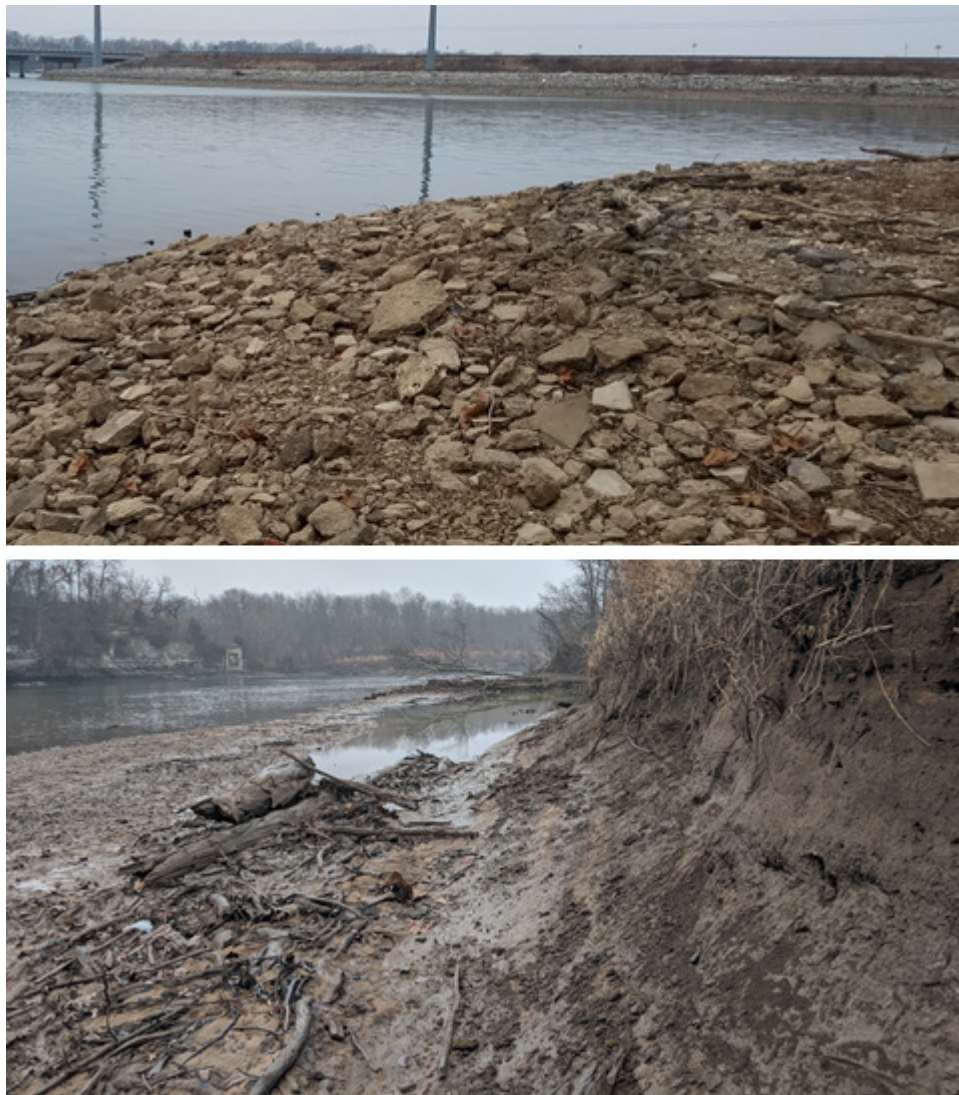
Figure 29
Visual Comparison of Different Sediment Types

Note: Top—non-cohesive sand, gravel, and cobbles; bottom—cohesive silt and clay.

Non-cohesive sediments such as sand, gravel, and cobbles (Figure 29, top photograph) tend to have easily predictable critical shear stress. It is typically proportional to sediment density and grain size and is relatively constant through the entire sediment layer. Generally, grains move relatively independently of each other. As a result, these sediments are comparatively simple to evaluate and model.

Modeling cohesive sediments is far more complex. Critical shear stress is determined primarily by the cohesive forces between silt and clay particles rather than individual grain sizes. This is complicated by the process of consolidation; as sediment is deposited in an area, it applies force to the underlying layers, compressing them and increasing the cohesion, making them less susceptible to erosion. The amount of time spent on the bed also affects consolidation and critical shear stress. Furthermore, erosion typically occurs as clumps break free of the surrounding sediment. Due to the changing resistance to erosion based on depth and the nature of cohesive sediment transport, it is considerably more difficult to accurately model and requires additional information.

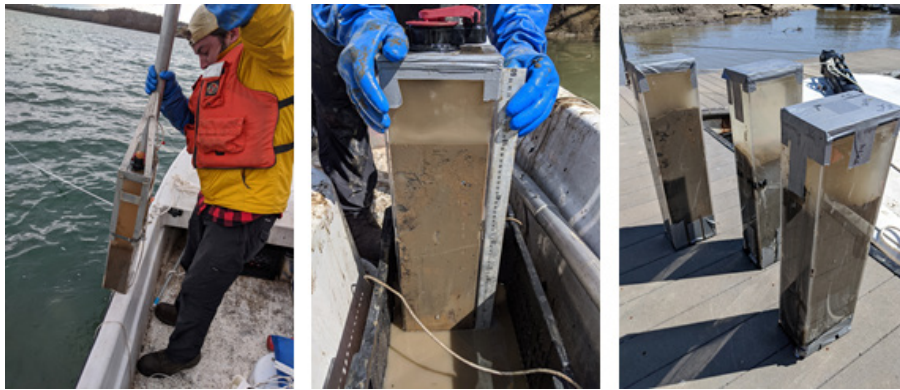
Figure 30
SEDflume Core Sampling

Note: Left—technician pulling box core rig out of the bed; center—box core showing sediment fill and measuring depth of sample; right—several collected samples before shipment to the test facility.

The study team collected core samples for SEDflume analysis in March 2020 (Figure 30). A total of 14 core samples were collected using a box push-core system (Figure 31). The box core was a clear plastic sleeve, which was pressed into the sediment bed. A pressure relief valve at the top of the core allowed air and water to escape as the core sank into the streambed. The resulting suction pressure kept the sample inside the sleeve as it was raised back to the water surface. The sample was then measured, sealed, and transported to the test laboratory for analysis.

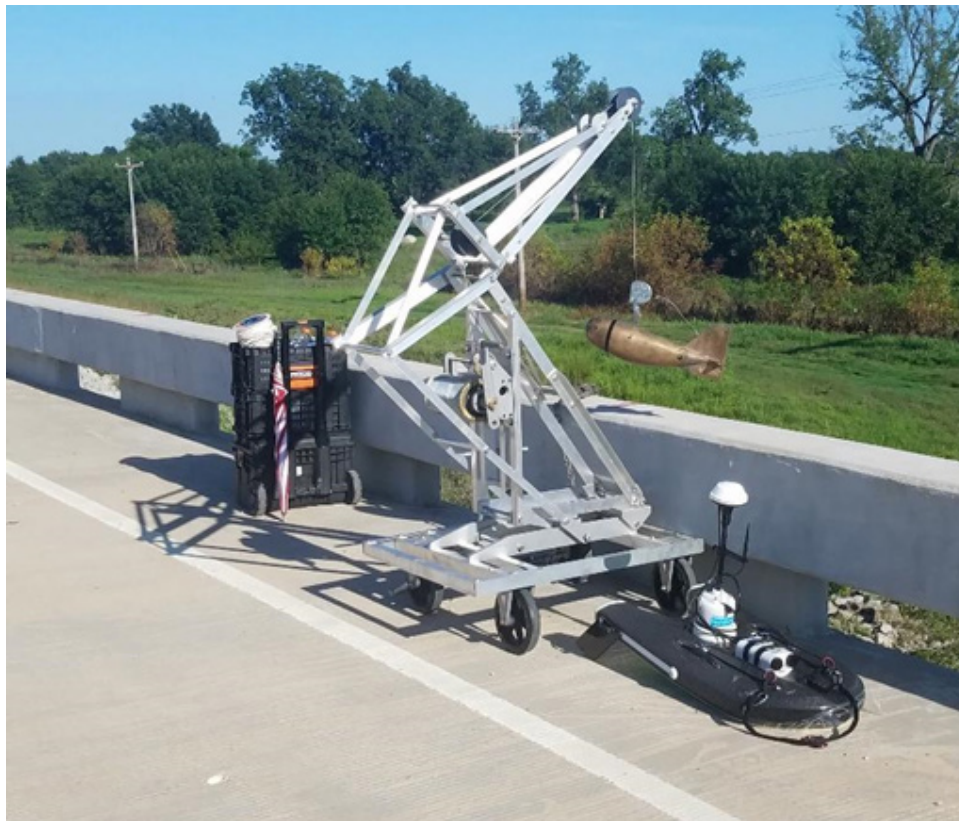
Figure 32
Sampling Equipment Used During Suspended Sediment Concentration Sampling Efforts

Notes: The D-74 water sampler is attached to the crane, and the SonTek M9 ADCP used to measure stream flows is in the lower right. Samples are placed in the carrier at left after collection.

A D-74 depth-integrating water sampler was used to collect SSC samples (Figure 32). This sampler features a finned body with a nozzle pointing upstream and a vent pointing downstream. As it is lowered into the water, flow is allowed through the nozzle and into a sampling bottle. The sampler is lowered into the stream until it reaches the bed, then is raised; this is all done at a constant speed. Based on flow conditions at the site, researchers have an array of nozzle sizes and travel speeds to choose to ensure valid data (USGS 2006).

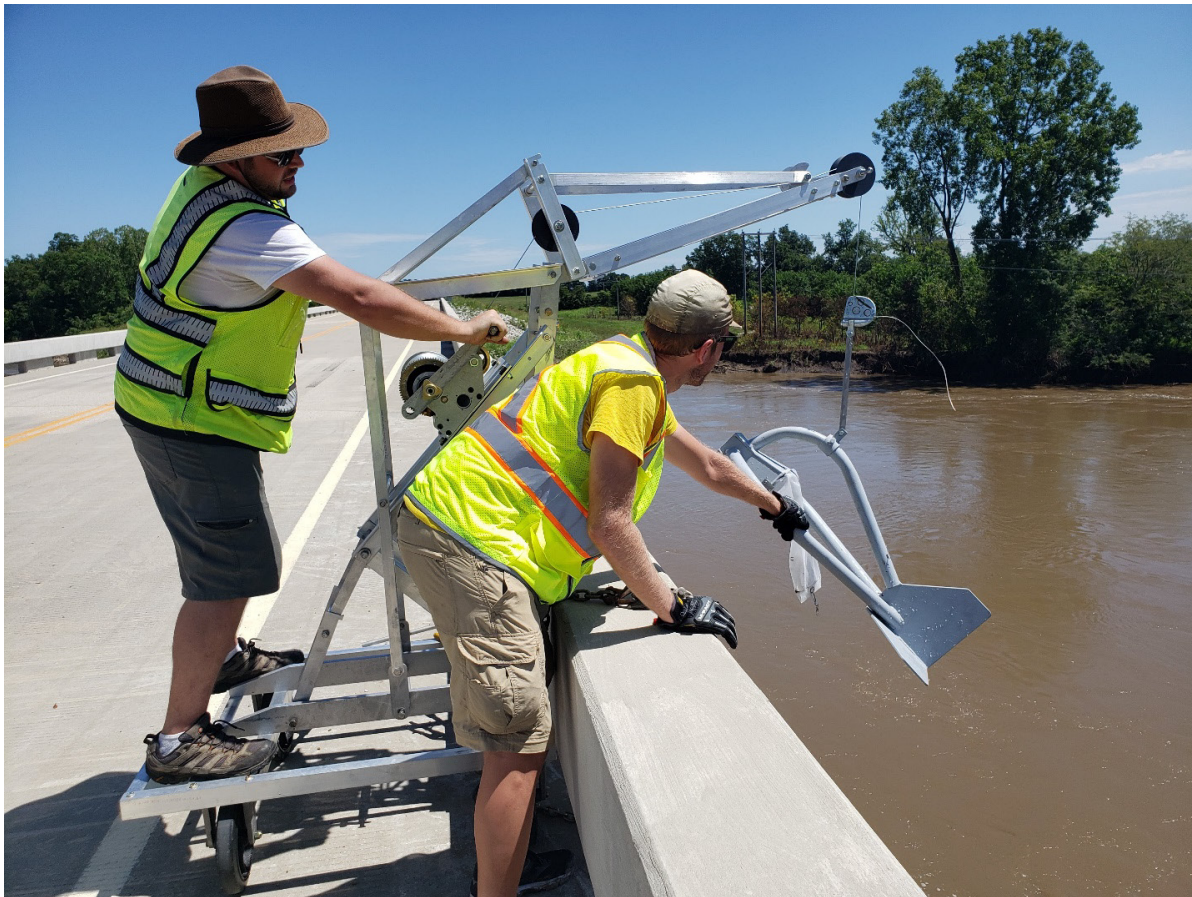
Figure 33
Bedload Transport Measurements Collected Using the Helley-Smith Sampler

of all sediment (SSC and bedload) moving through the system under given flow conditions. The Helley-Smith sampler sits on the streambed with a rectangular opening pointed upstream. Saltating, sliding, and rolling sediment is transported at the bed surface into the opening and trapped in a mesh bag. USGS documentation provides guidelines for the use of this equipment; Anchor QEA followed USGS procedures (Edwards and Glysson 1999) to collect bedload sediment during site visits (Table 6).

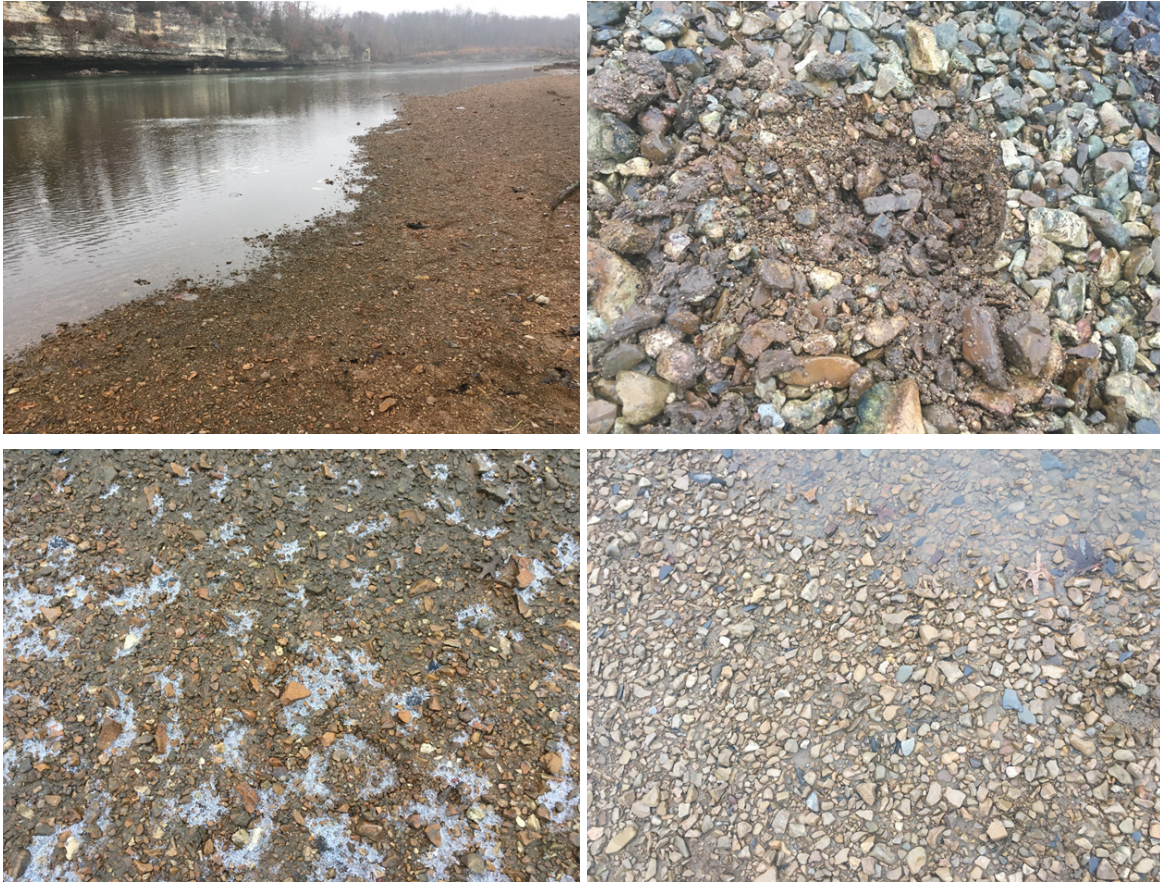
Note: Clockwise from top left, the Spring River, Tar Creek, Elk River, and Neosho River.

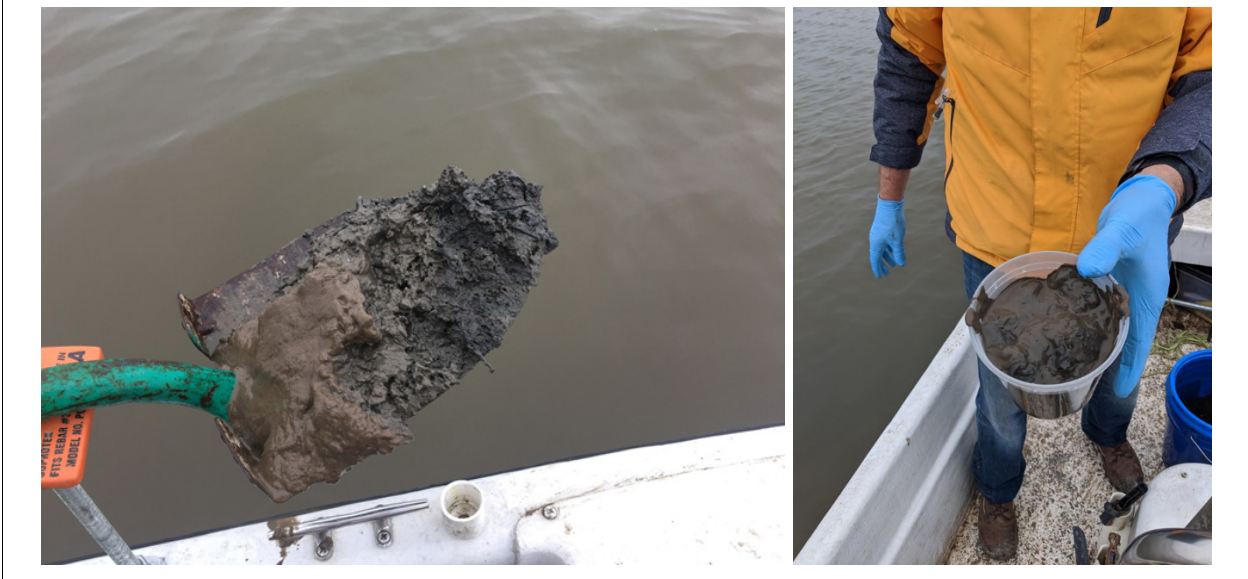
Figure 38
Sediment Grab Samples Collected from the Reservoir Bed in Grand Lake

Farther downstream, as the tributaries transition into lacustrine conditions, the character of the bed material changes dramatically. Samples collected from the reservoir bed appear to consist primarily of silt and clay (Figure 38).

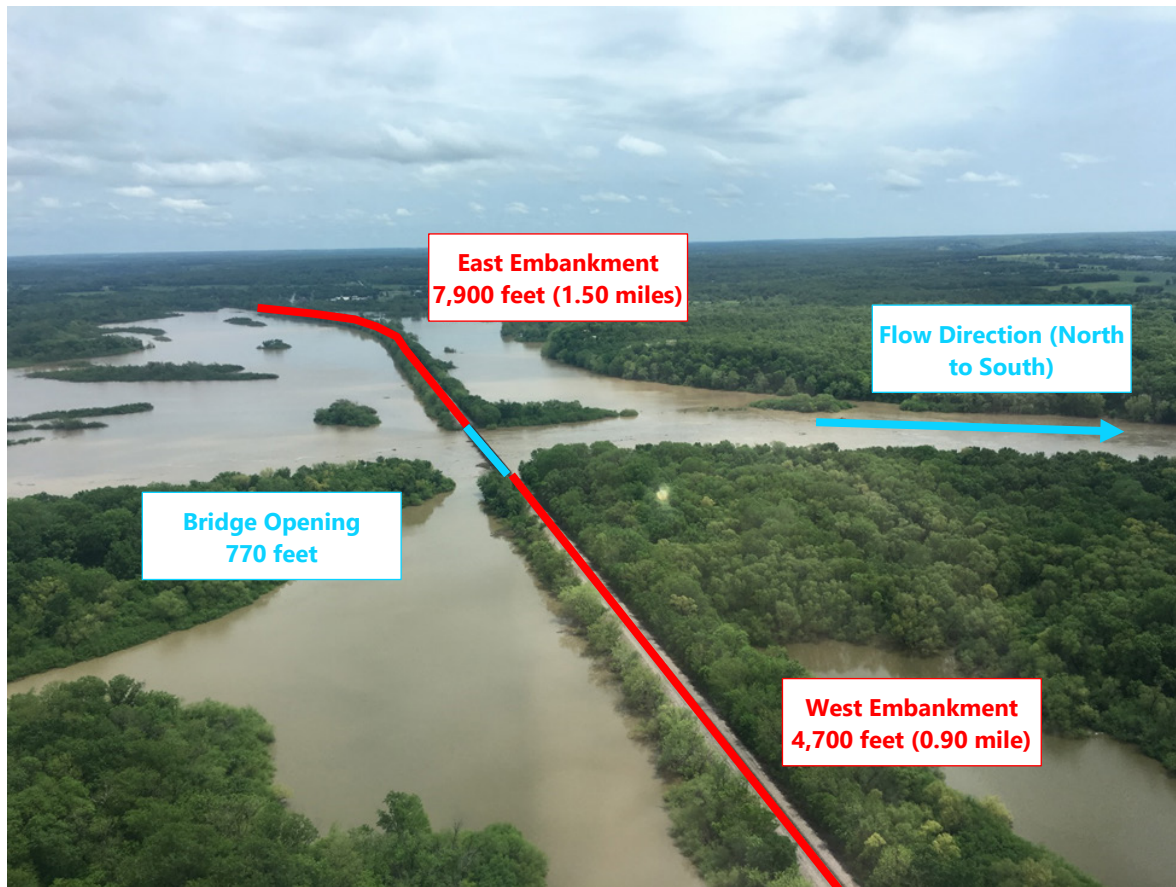
Figure 69
Burlington Northern Railroad Bridge and Embankment near Twin Bridges Photograph Looking East

Notes: Photograph taken on May 2, 2019; USGS reported daily discharges were as follows:

- Neosho River near Commerce: 37,700 cfs (USGS 2021a)
- Tar Creek near Commerce: 192 cfs (USGS 2021c)
- Spring River near Quapaw: 48,500 cfs (USGS 2021e)

An extreme example of bridge encroachment on the river and floodplain is the railroad bridge just downstream of the Twin Bridge area below the confluence of the Neosho and Spring rivers. Figure 68 and Figure 69 present aerial views of this area.

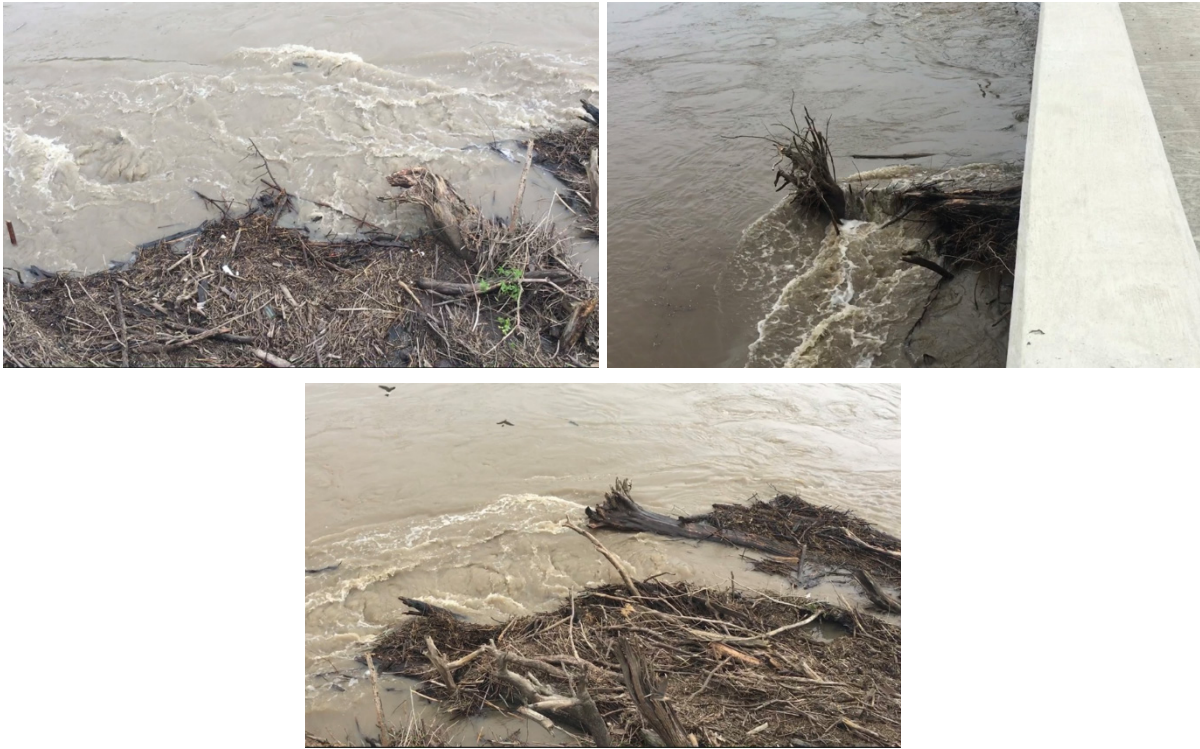
Figure 71
May 2019 Photographs of Debris Trapped on Bridge Piers

Bridge piers frequently trap debris because moderate to high flow events carry floating trees and other materials. The following images show debris trapped on bridge piers during the flow event that occurred late in April through May 2019. Peak daily flow on the Neosho River was 90,100 cubic feet per second (cfs) on May 24, 2019; however, the photographs of debris were taken in early May before the flood peak (Figure 71).

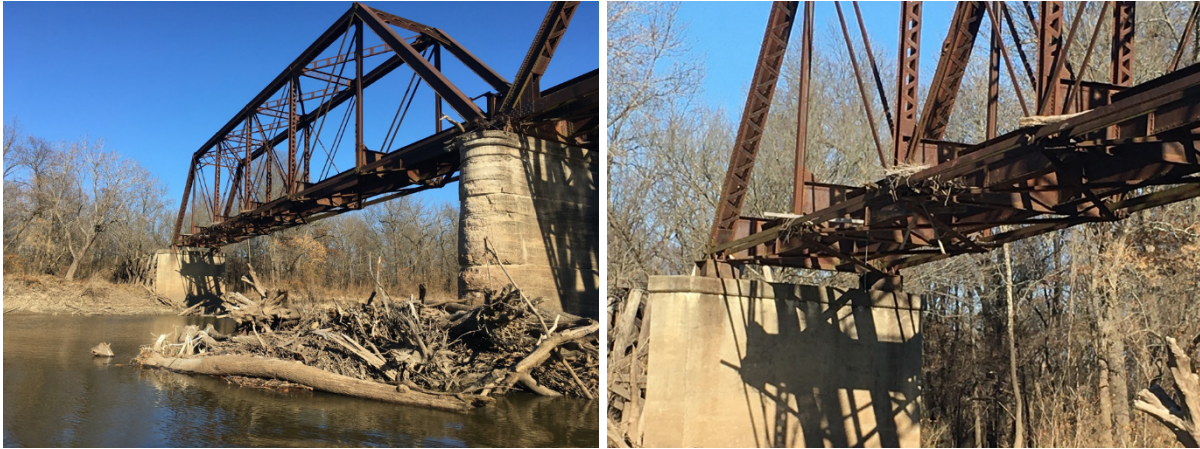
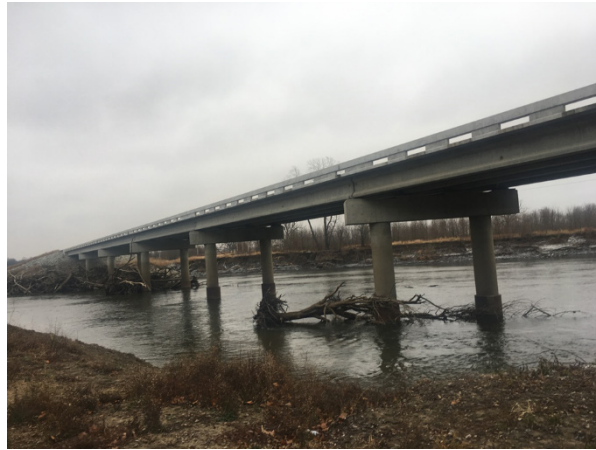
Figure 72
December 2019 Photographs of Debris Trapped on Bridge Piers

Notes: Top photographs show the abandoned railroad bridge at RM 134.60, approximately 0.6 mile upstream of the Tar Creek confluence.
Bottom photograph is from the East 60th Road Bridge (USGS Neosho River near Commerce gage) at RM 145.4.

Additional photographs were taken in December 2019, months after the peak flow in May 2019. The photographs show evidence of debris trapped on bridges, with some debris up on the bridge deck itself (Figure 72).

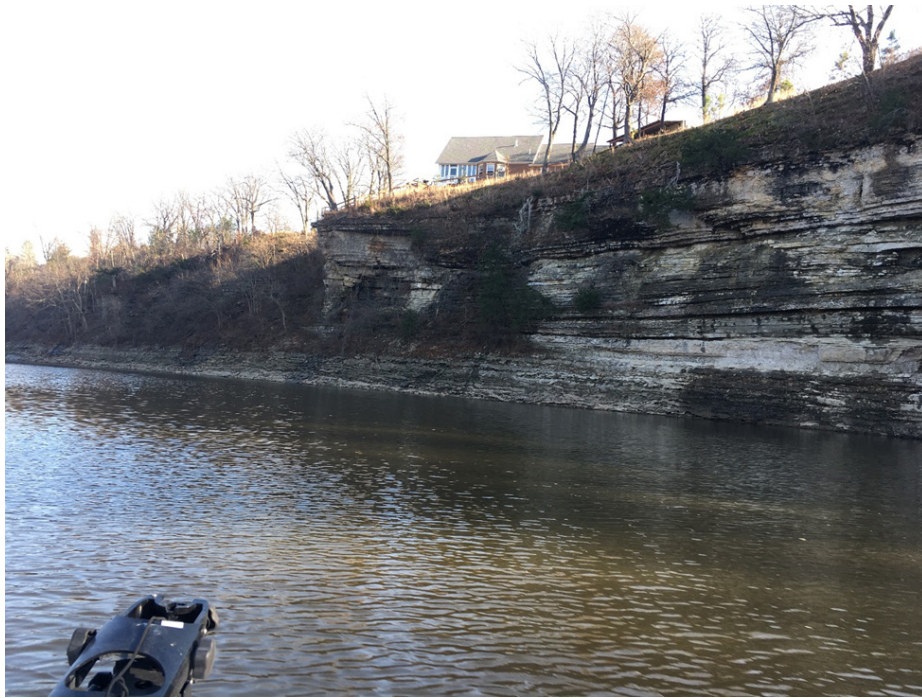
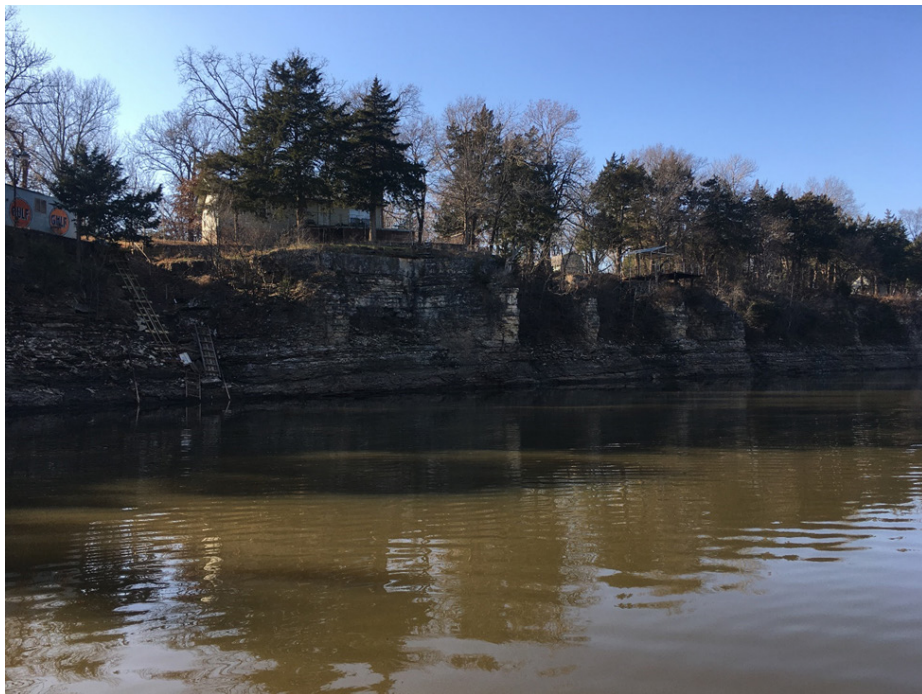
Figure 73
Photographs of Vertical Rocky Banks Along the Neosho River

Notes: Top photograph was taken near RM 129.07 on the Neosho River, approximately 2.4 miles upstream of Connors Bridge.
Bottom photograph was taken near RM 127.47 on the Neosho River, approximately 0.75 mile upstream of Connors Bridge.

Vertical rock banks are evident in various reaches along the Neosho River. Examples of vertical rock banks are shown in Figure 73.

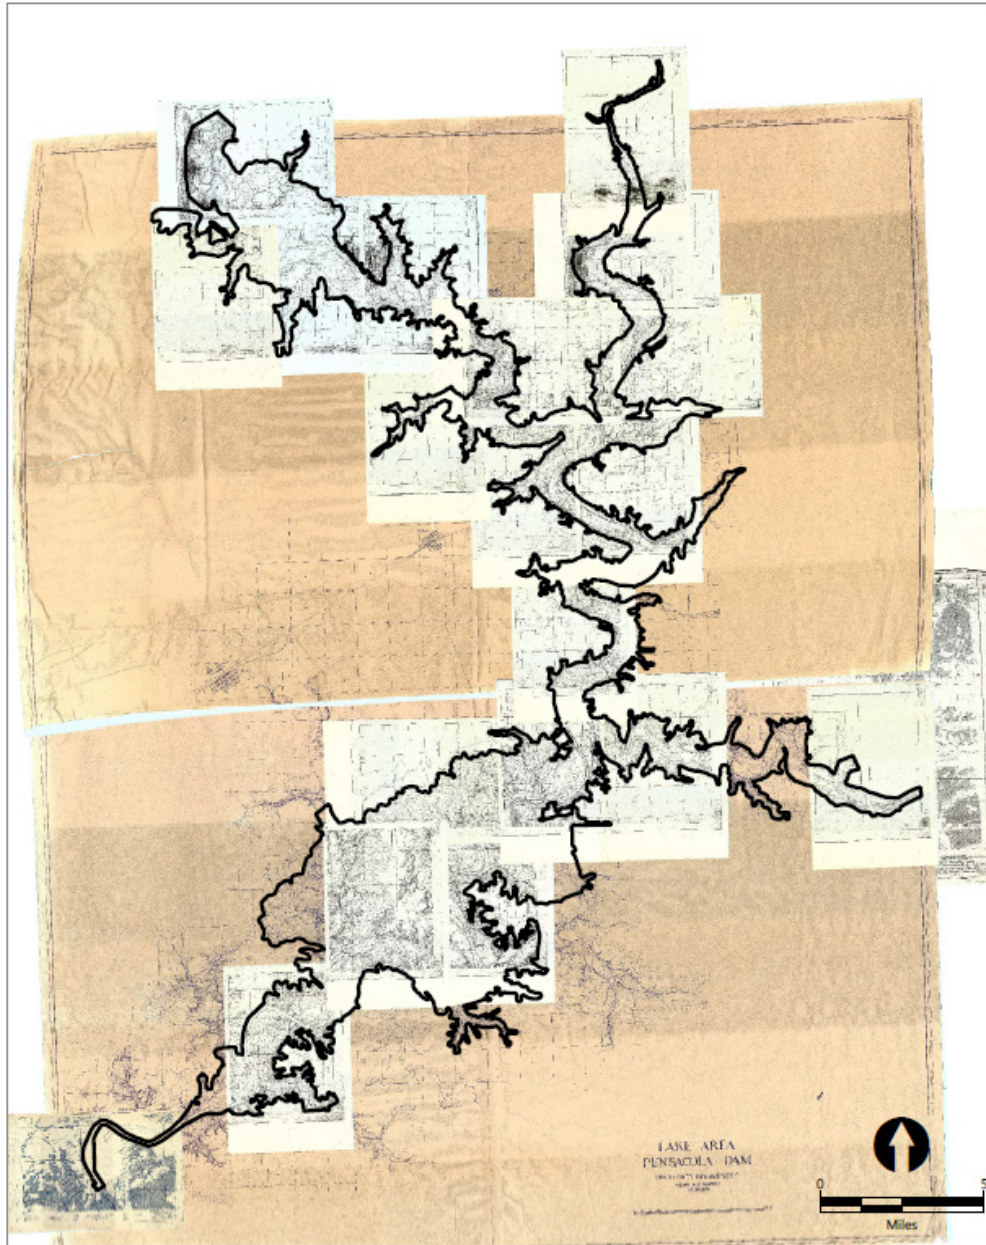
Figure 107
Graphic Showing Map Coverage of the Study Area

Note: The maps on white background are the 1:10,000 scale contour maps with legible, labeled contour elevations; maps with a brown background are the 1:31,680 scale with no legible contour elevation labels.

topographic surface; the 1:31,680 maps were only used where the others could not be used (Figure 107).

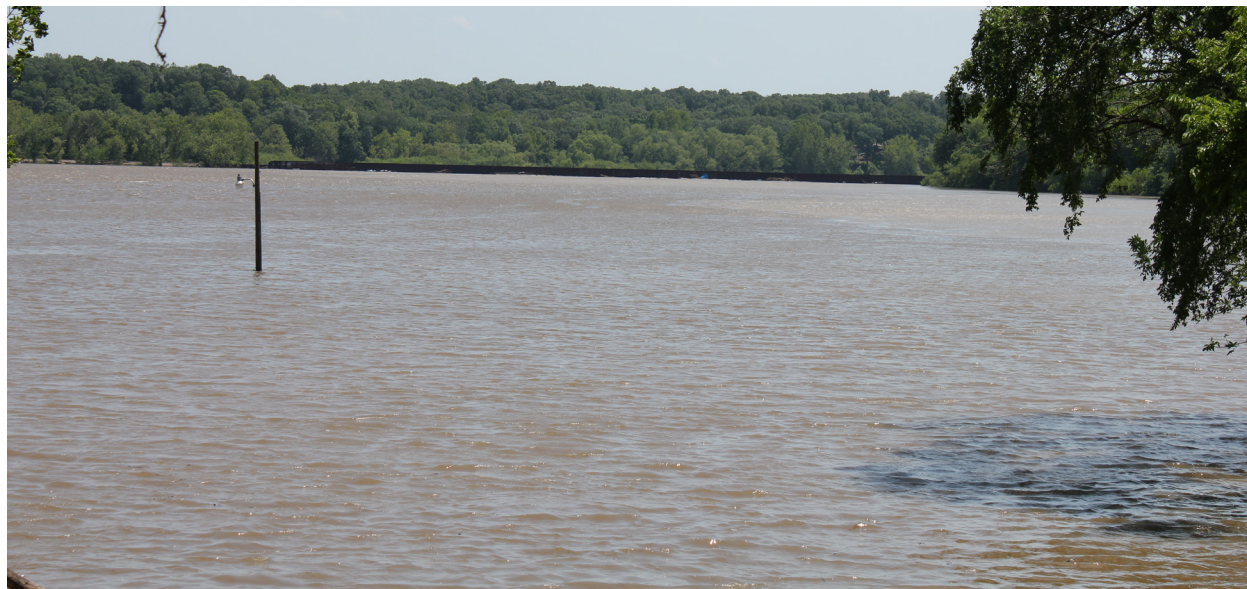
Figure 128

Burlington Northern Railroad Bridge and Embankment Viewed from Twin Bridges Boat Launch in May 2019

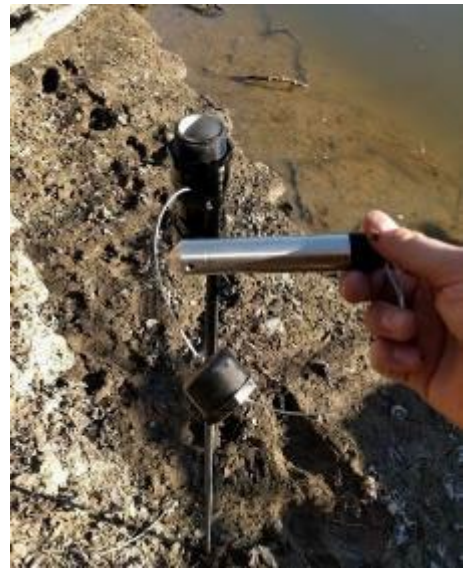
Figure 2
HOBO water level logger prior to deployment

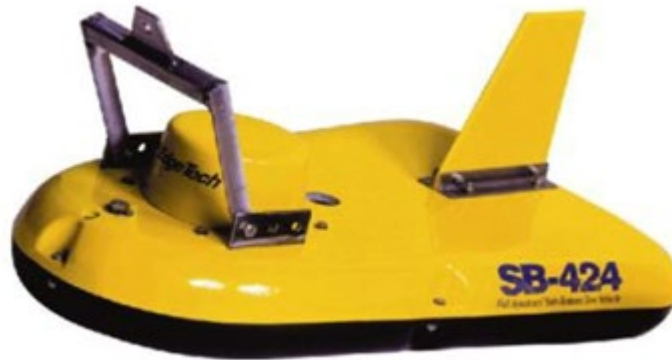
Figure 2
EdgeTech 424 Sub-Bottom Profiler Towfish

Note: The EdgeTech SB-424 is a tow vehicle that was pulled across the measured transects. The topside 3100-P portable sub-bottom profiling system with Discover software is not shown in this image.

The survey team used a 19-ft vessel to tow an EdgeTech SB-424 towfish (Figure 2). The towfish was pulled across each of the nine transects on the Neosho River to collect SBP data. The system was processed onboard using the EdgeTech 3100-P portable sub-bottom topside electronics and Discover software that displayed and stored data. The reported SB-424 specifications are shown in Table 1.

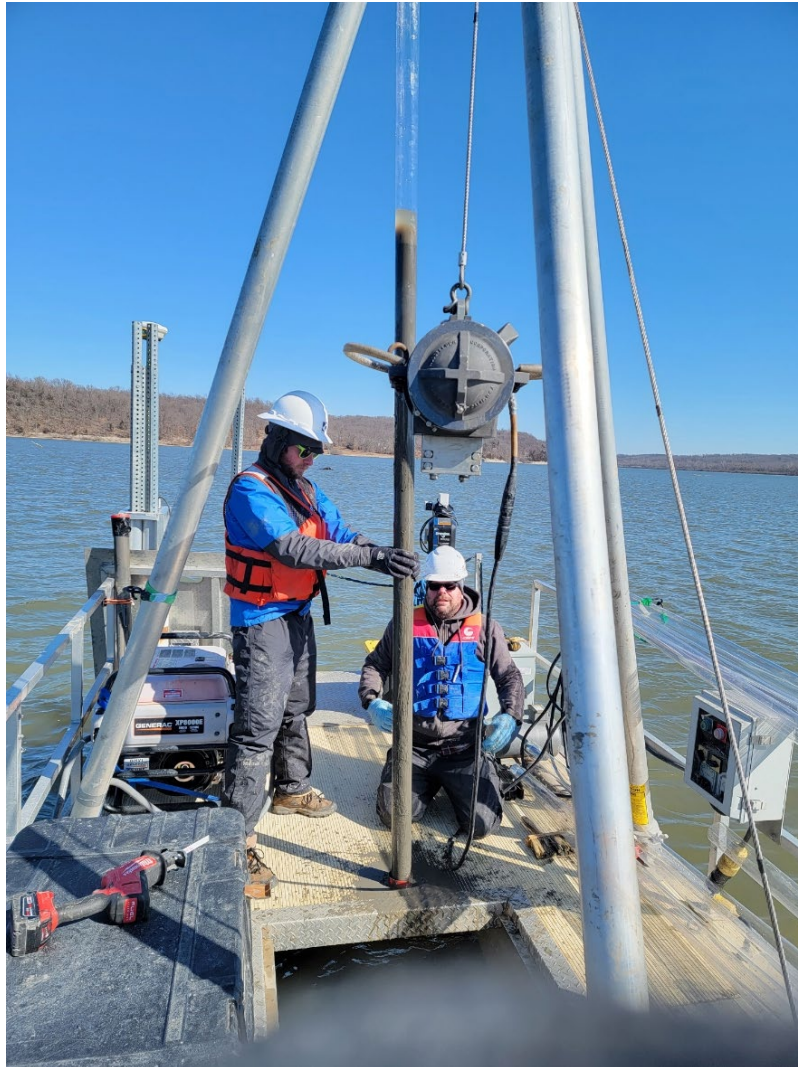
Figure 3
Vibracore System Used during February 2022 Sample Collection

The vibracore used for this effort was a Rossfelder P-3 system. The head clamped onto 16-ft clear ceramic tubes and was lowered to the bed with an electric winch from a vessel-mounted tripod system (Figure 3). Location data was collected with an RTK-GPS unit onboard the sampling boat.

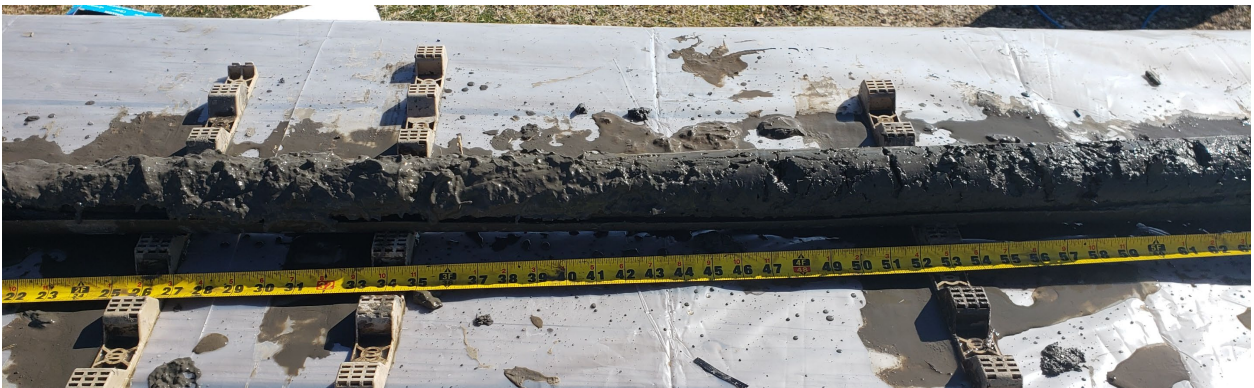
Figure 9
Image of Core 5.1-2 during Processing

Sediment cores were subdivided by cutting along the length of the core tube using an electric shear. Total recovered length was measured and recorded (Figure 9). Plastic spoons were used to mark the divisions between samples. Cores sent for grain size analyses were divided into 1-ft segments, and Cs-137 samples into 4-cm increments for laboratory assessment by Teledyne Brown Engineering. The spoons were then used to scoop samples into a clean container while avoiding the outer 1.5 cm of the core sample to prevent mixing of material smeared along the sample tube itself. Once used, the spoons were discarded to avoid contamination of any other samples. Sample containers were labeled, sealed, and packaged for transport. Because these were for grain size and Cs-137 analysis, there was no need for preservatives or cooling.
