Water Surface Elevation Monitoring

March 2022
Sedimentation Study

2022 Grand River Water Level Monitoring

Prepared for
Grand River Dam Authority
226 West Dwain Willis
Vinita, OK 74301

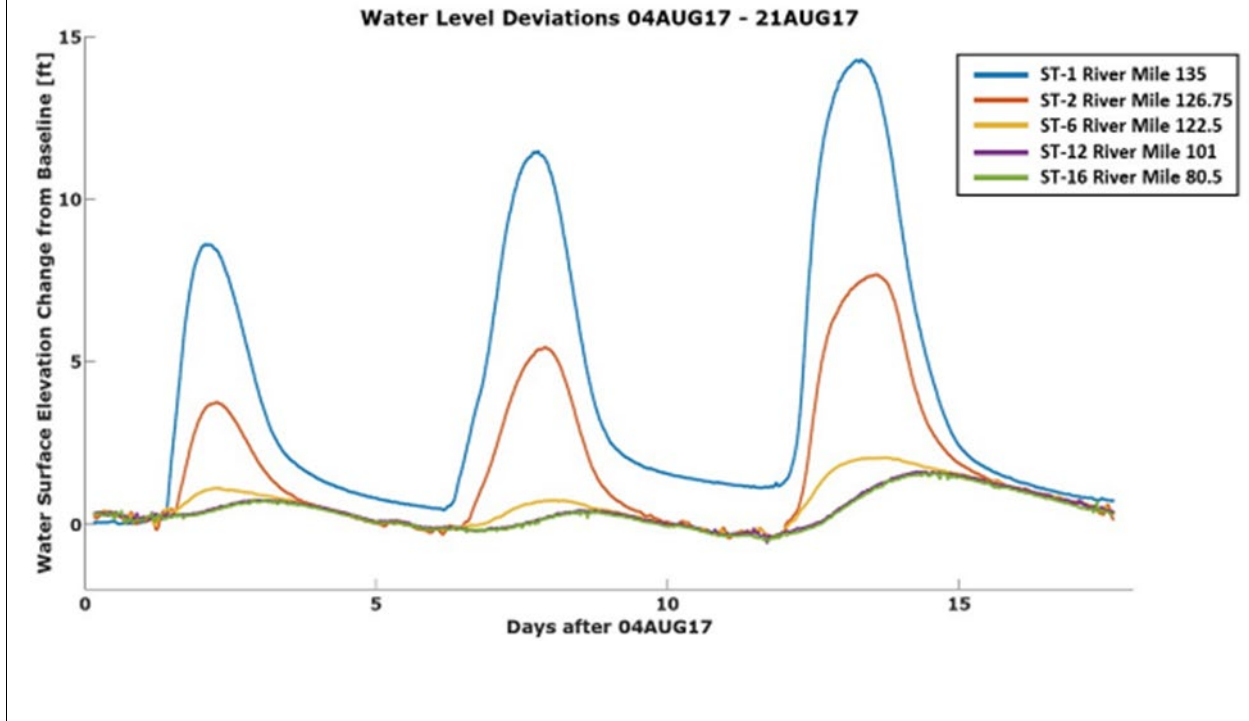
Figure 5
Flood hydrographs of a series of three floods in August 2017. Selected HOBO logging stations are shown to display differences in hydrograph character throughout the watershed.

Table 4
Key parameters of the August 2017 floods shown in Figure 5

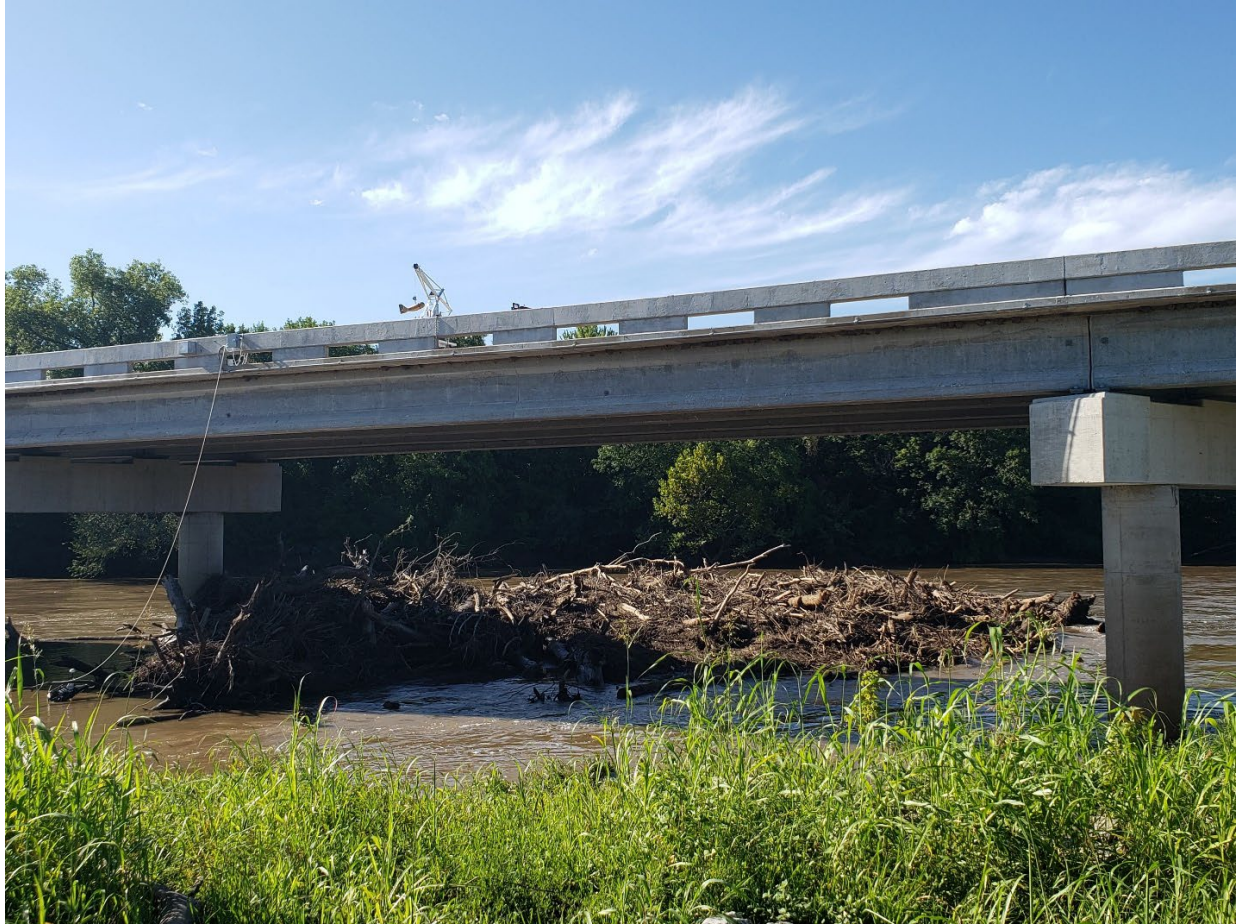
Figure 6
Photo of blockage taken in August 2019. Debris pile remains in place and has grown since photo was taken.

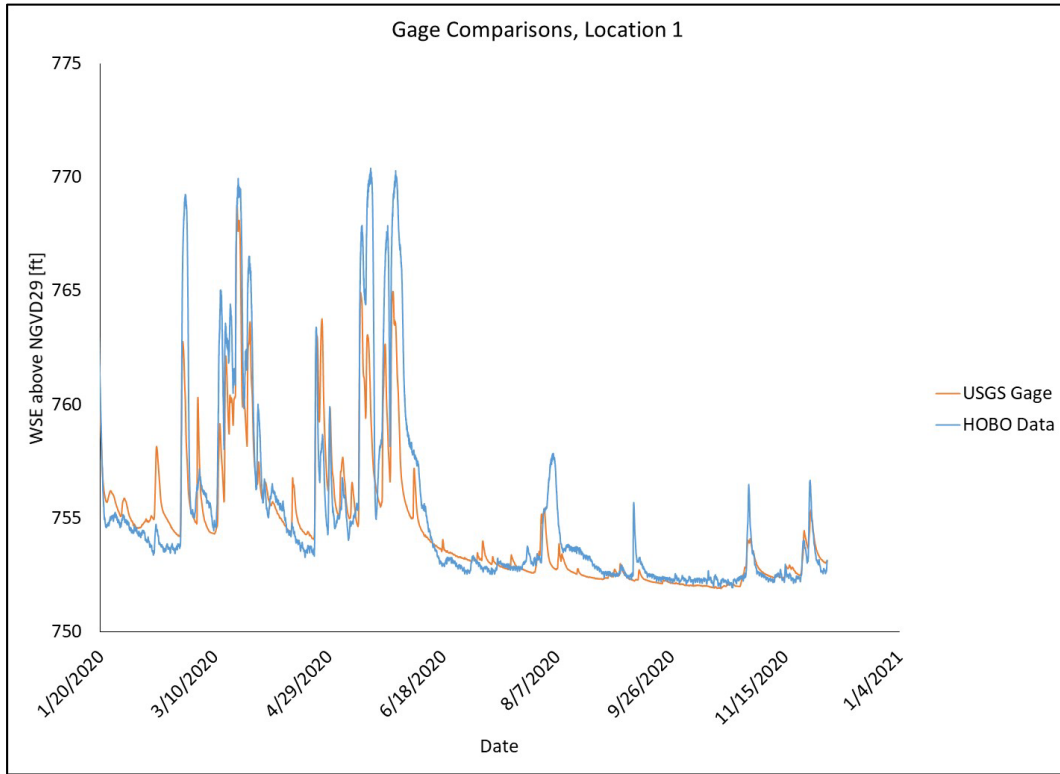
Figure A17
Station 1 2020 data compared to USGS Gage 07185000 (Neosho River near Commerce, OK).

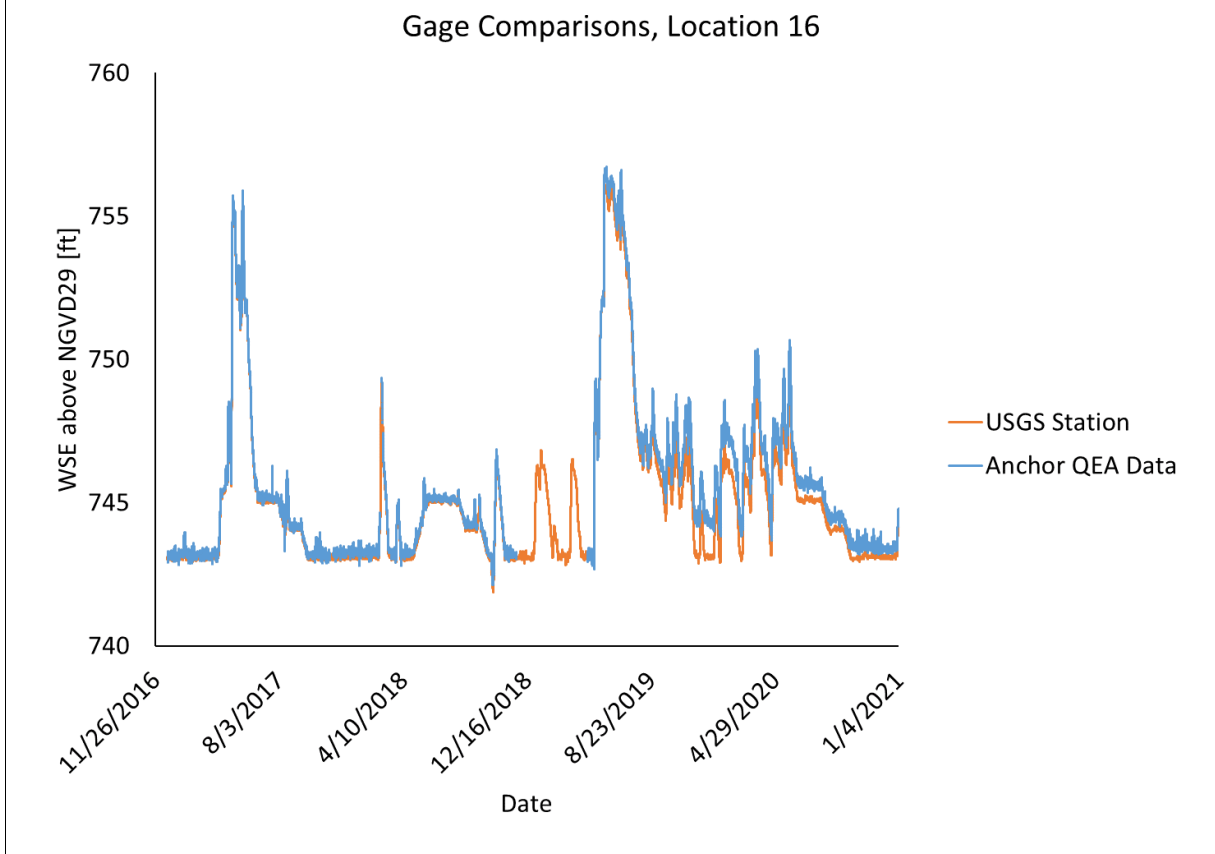
Figure A18

Station 16 compared to USGS Gage 07190000 (Lake O' the Cherokees at Langley, OK).

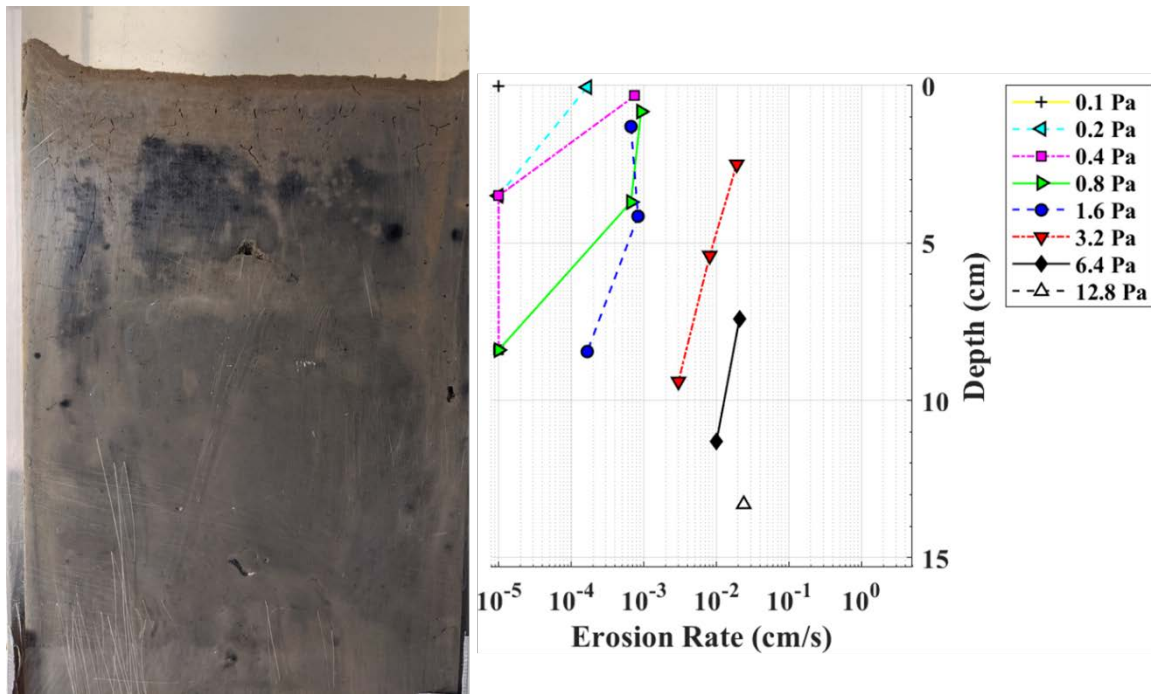
Figure 17. Photograph of Core NR-202 aligned with applied shear stresses and associated erosion rates

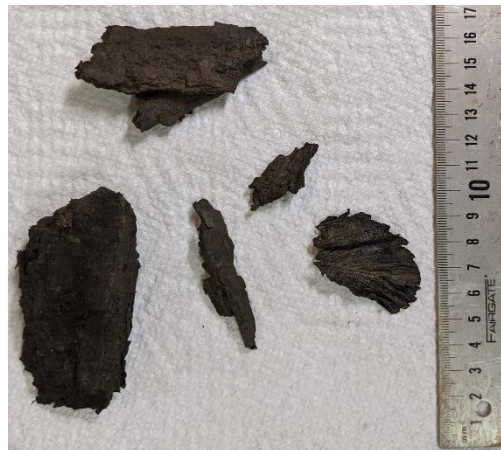
Figure 38. Wood chips found in SR-114

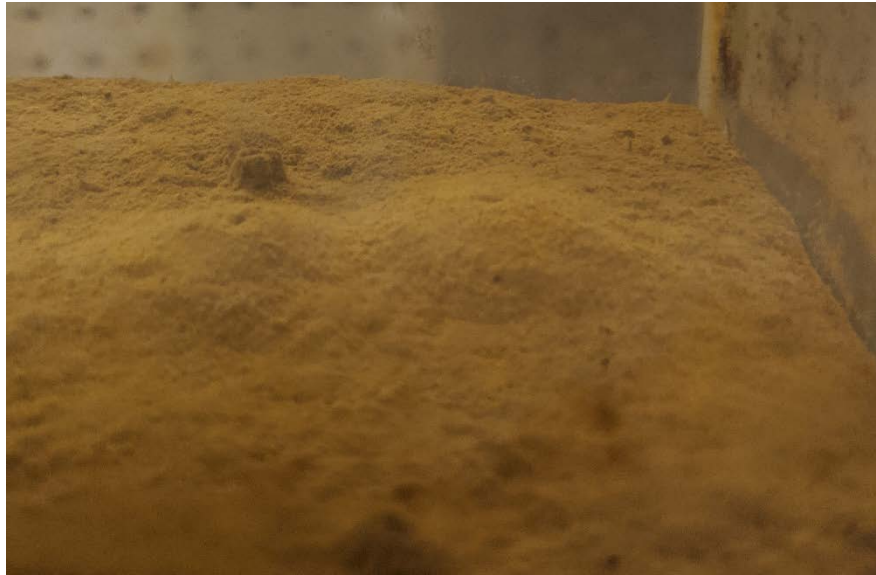
Figure 39. Evidence of biotic activity on surface of SR-TB

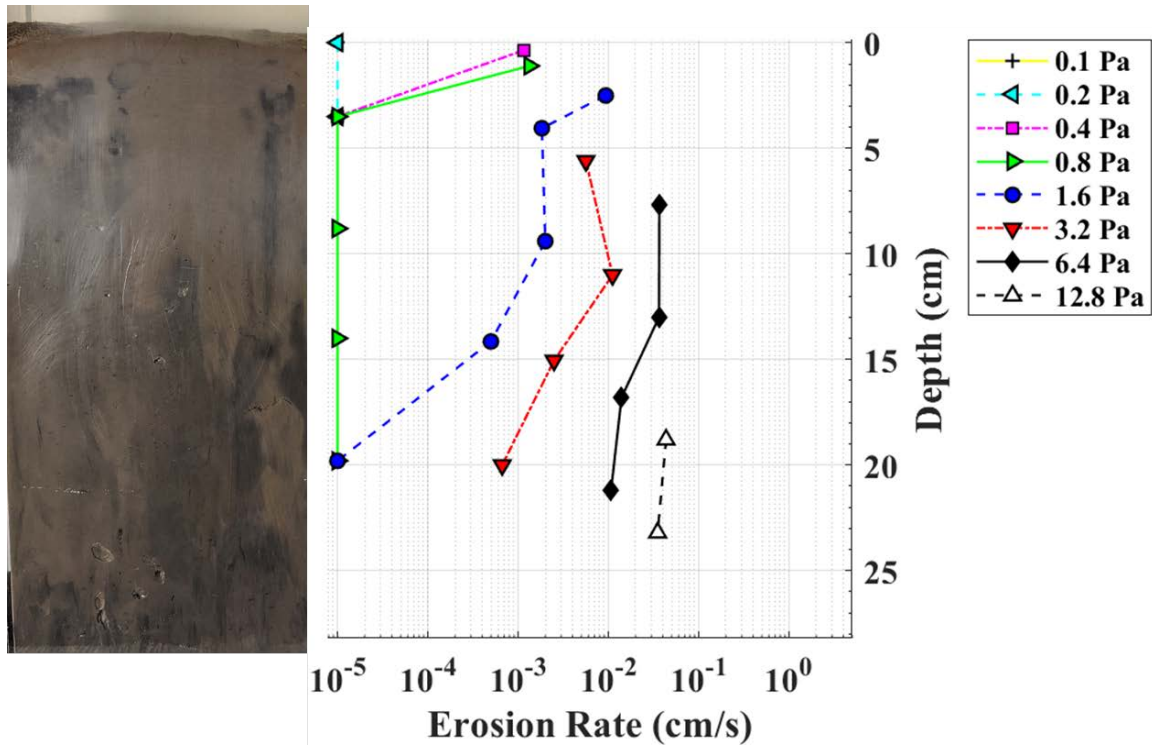
Figure 40. Photograph of Core SR-TB aligned with applied shear stresses and associated erosion rates

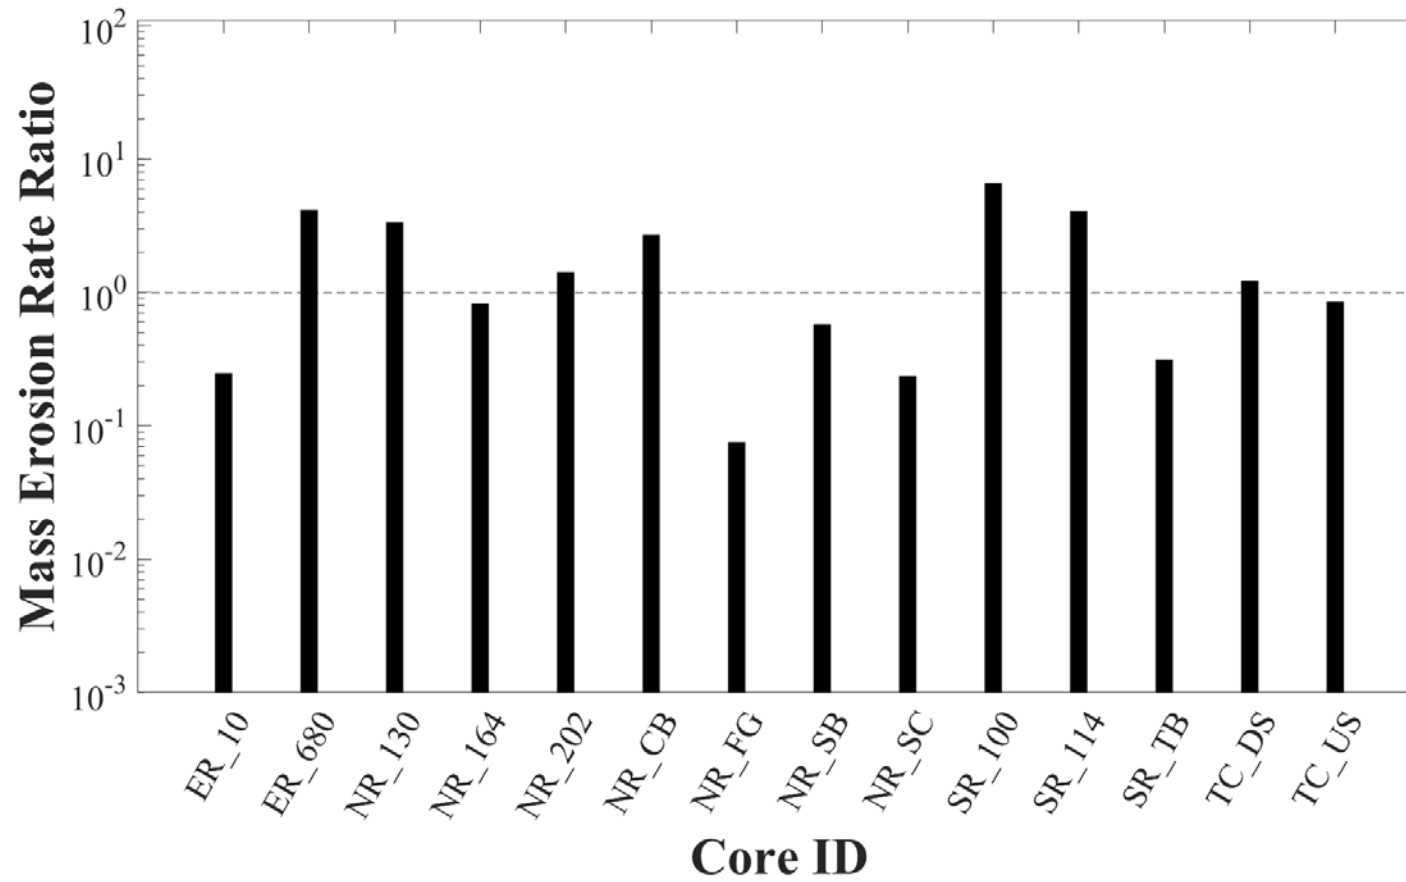
Figure 49. Intercore erosion rate ratios: Depth-averaged core erosion rates compared to the site-wide average erosion rates.
